# Case Study

## India's First Water Neutral Campus BSF Campus, Bhondsi, Gurugram

## 1. Xebia CSR Project: Twin Pond Rejuvenation and 50 KLD DEWATS

## 2. Brookfield Properties Pvt. Ltd. Pond Development

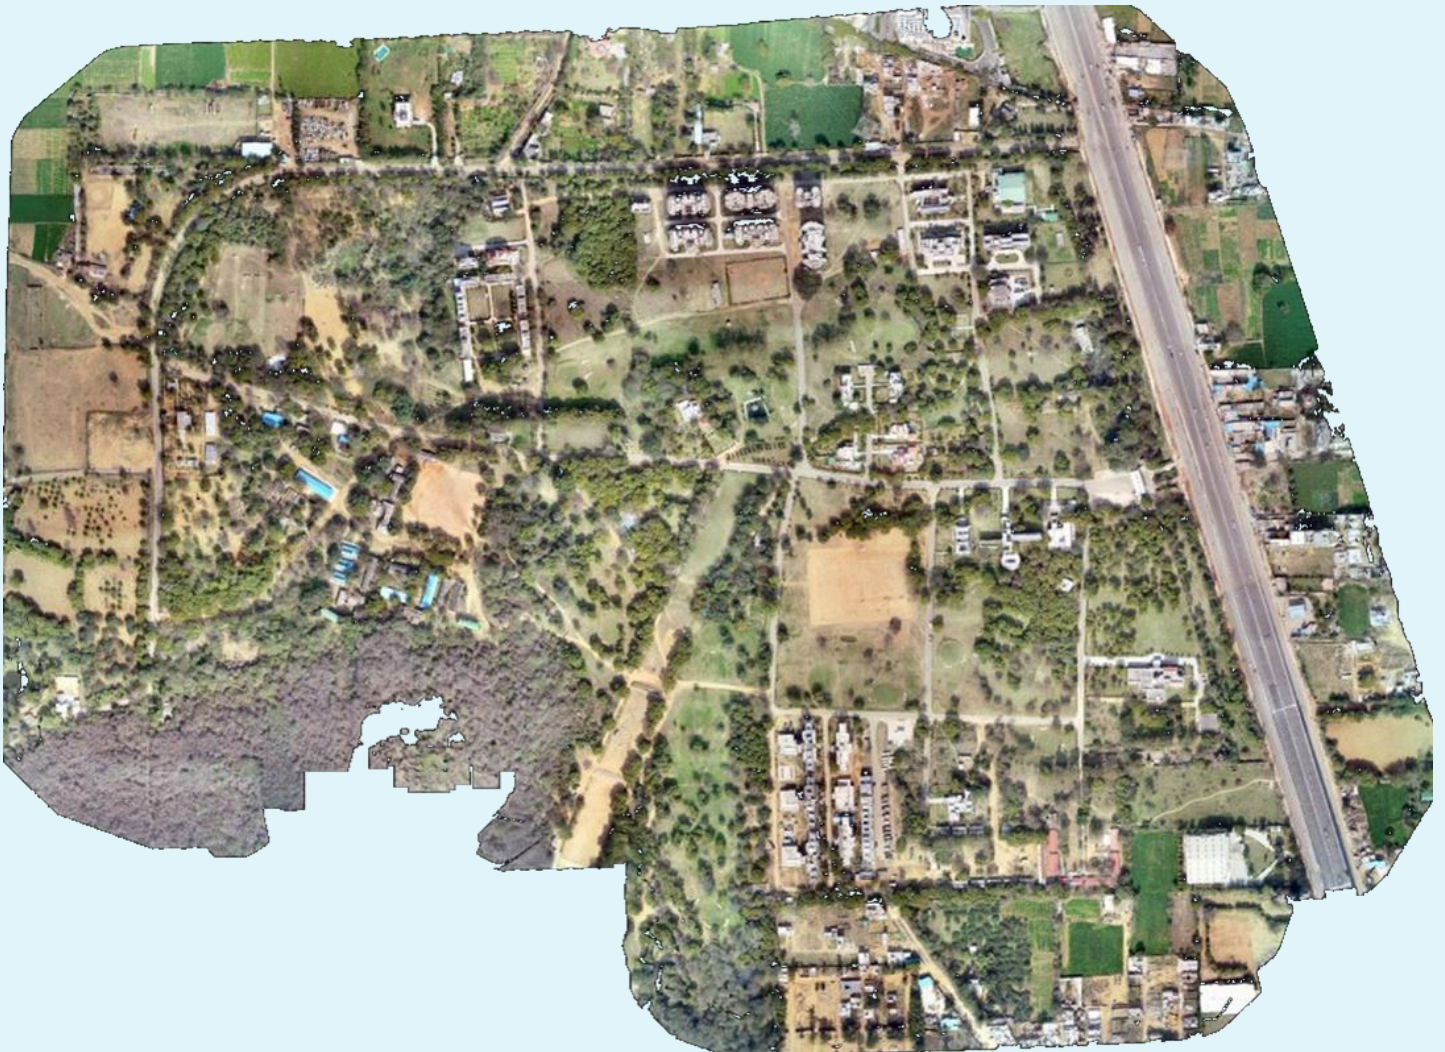
*Figure 1: 95 Battalion BSF Campus Bhondsi, Gurugram*

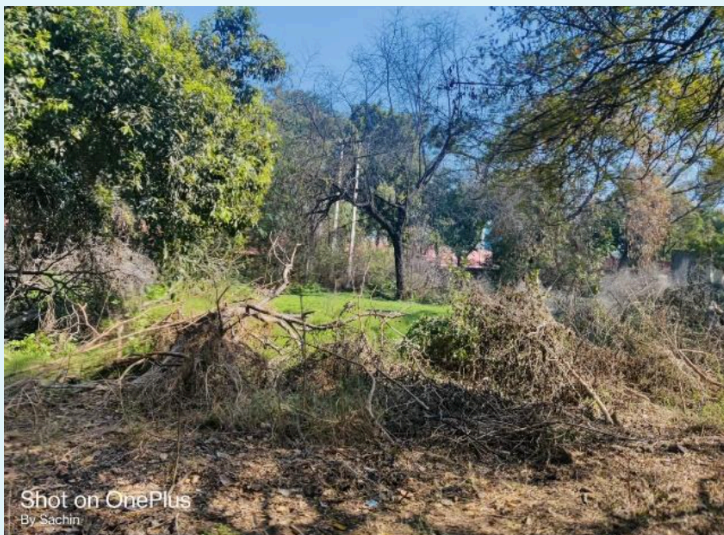
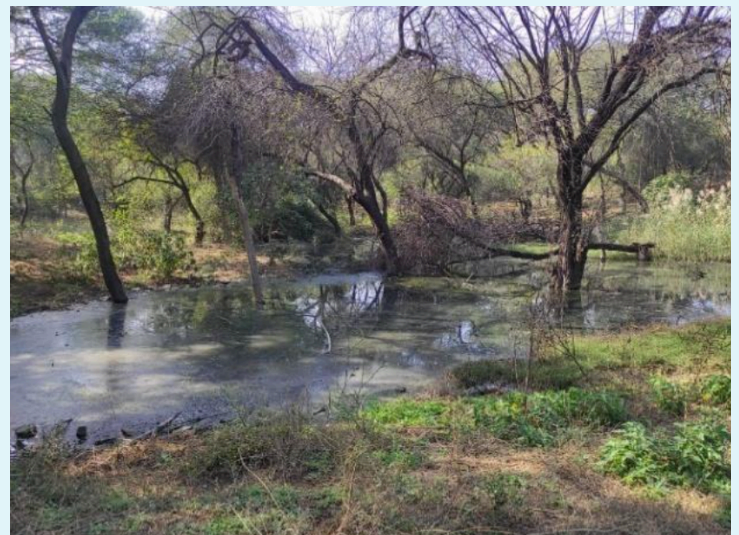
- Dual Unmanaged Depressions: Two degraded earthen basins—one seasonally dry, the other choked with untreated wastewater.
- Raw Sewage & Greywater Pooling: Unchecked overflow from barracks, mess, and Dhobi Ghat created stagnant, unhygienic pools.
- Severe Groundwater Stress: Heavy borewell reliance dropped static water tables to ~45 mbgl with zero artificial recharge.
- Soil Erosion & Slope Instability: Monsoon runoff scoured uncompacted embankment slopes, causing continuous bank collapse.

Figure: Wastewater sludge across the site

- Pond Profiling & Dredging: Removed invasive vegetation and accumulated sludge, reshaping the two depressions into a functional dual-pond system.
- Geo-Coir Erosion Control: Installed 700 GSM Geo-Coir matting, anchored with bamboo stakes, to stabilize pond embankments and reduce rainfall-induced erosion.

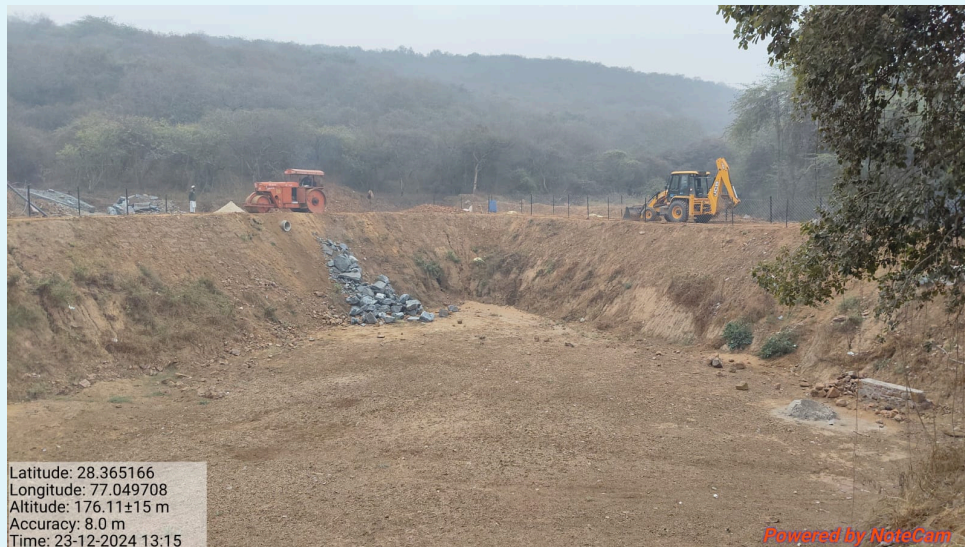
Figure : Development of Pond Area

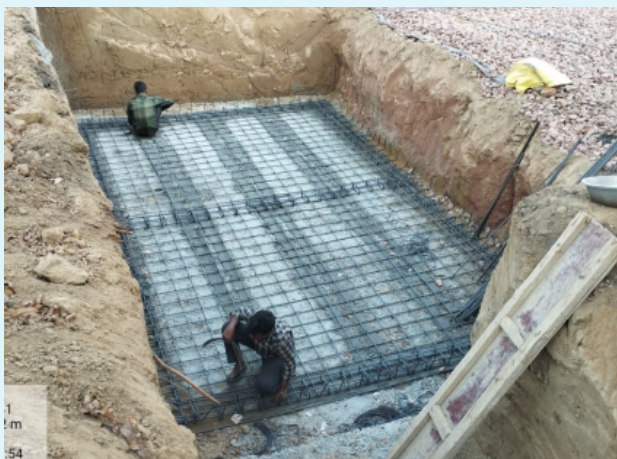
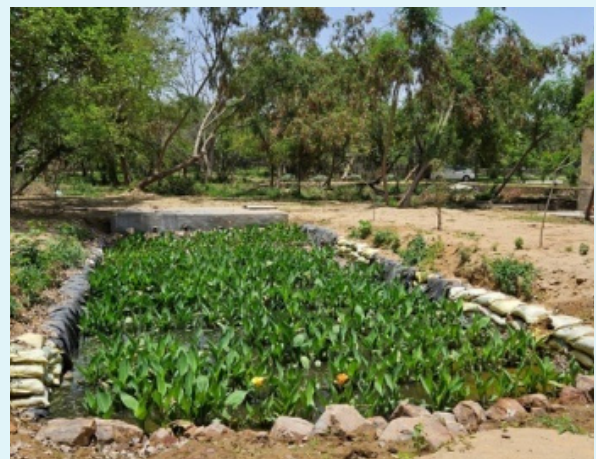
Figure : Constructed Wetland Development

- Screen Chamber: Removes coarse debris.
- Settler Tank: Settles suspended solids.
- Anaerobic Baffled Reactor (ABR): Uses anaerobic bacteria to break down organic pollutants.
- Constructed Wetland: Gravel-based wetland with Red Canna, Phragmites and Typha for natural filtration and nutrient removal.
- Bio-Swales & Dual Ponds: Vegetated channels further polish treated water before it enters the Polishing and Main Ponds.

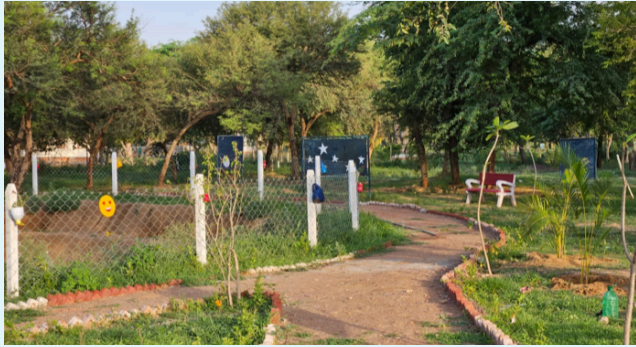
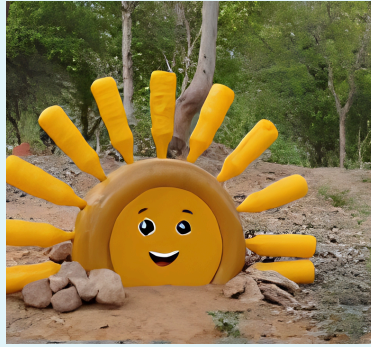
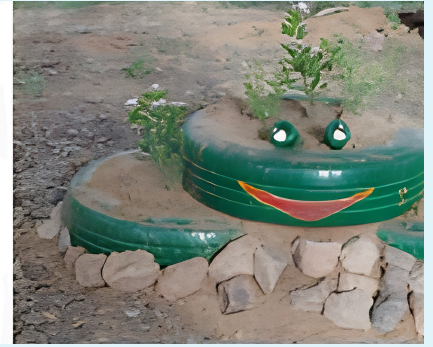
- Military & Plastic Waste Diverted: Discarded BSF helmets were painted and converted into hanging bird feeders. Waste vehicle tyres were transformed into frog sculptures and playground seating, while single-use plastic bottles were upcycled into garden art installations.

*Figure : Landscaping elements made up of waste material*

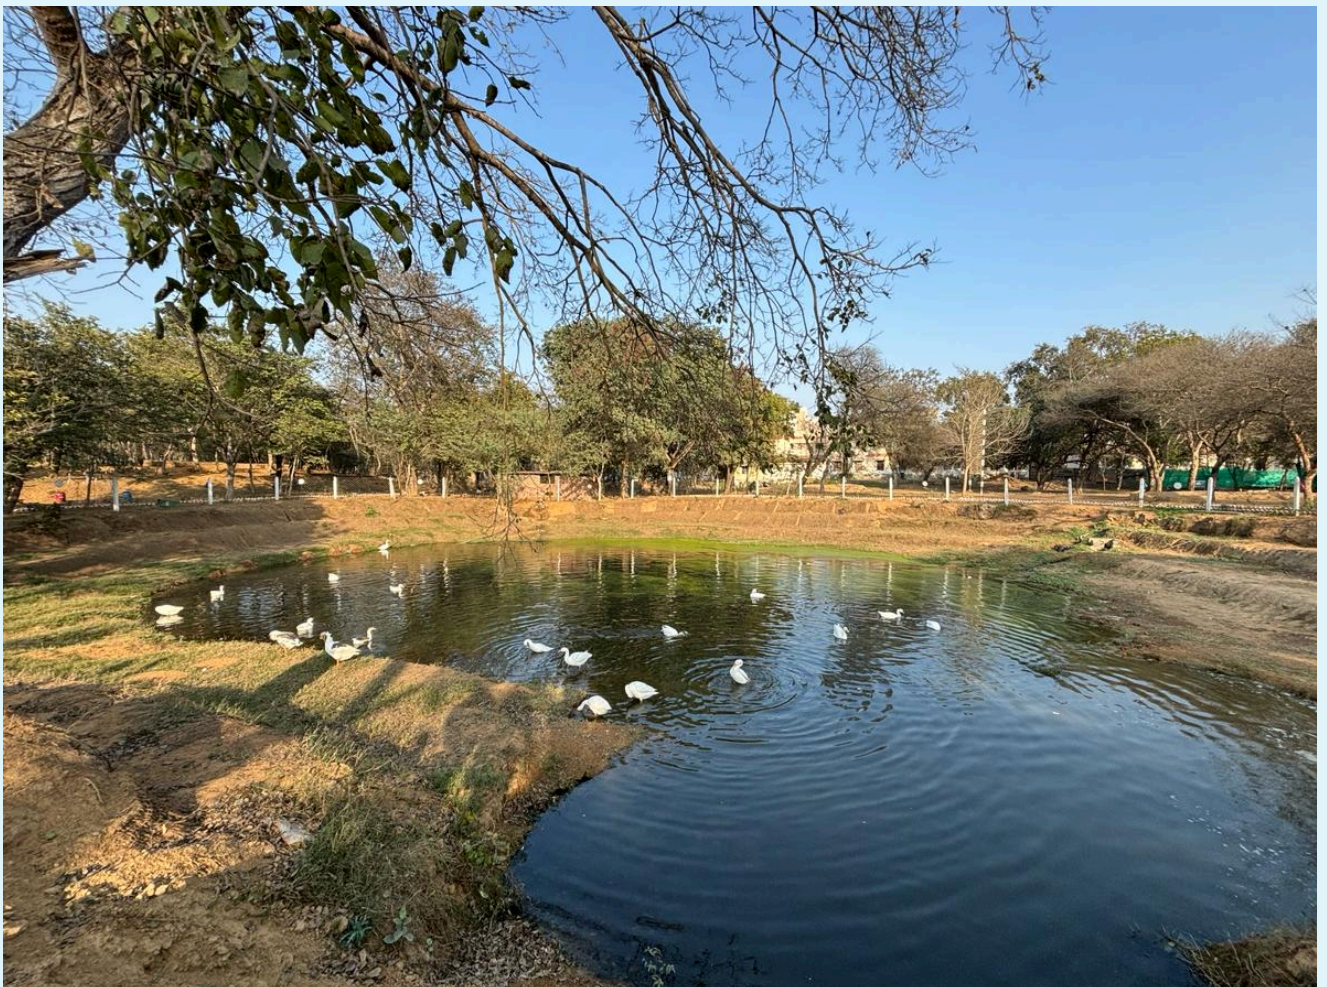
*Figure : Restored Double Structured Pond*

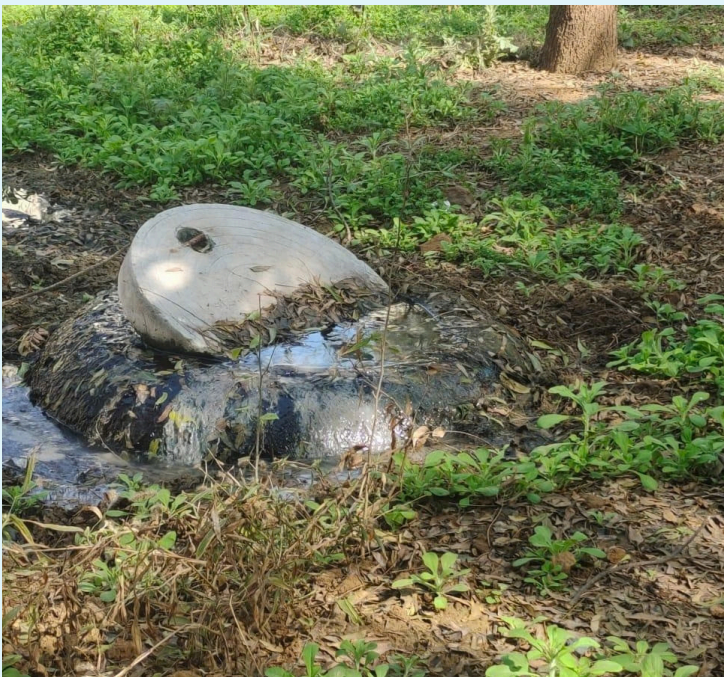
*Figure: Sewage Overflow from Manhole*

- Site Demarcation: Demarcated a 0.5-acre site near the Administrative Block.
- Pond Rejuvenation: Created an 836 sq.m pond, 3 m deep, with Geo-Coir matting for slope stabilization.
- 50 KLD DEWATS: Installed a decentralized treatment system using an ABR and 200 sq.m constructed wetlands for natural wastewater treatment.
- Water Channelization: Routed sewage through treatment units into the pond and channelized rainwater runoff for recharge.

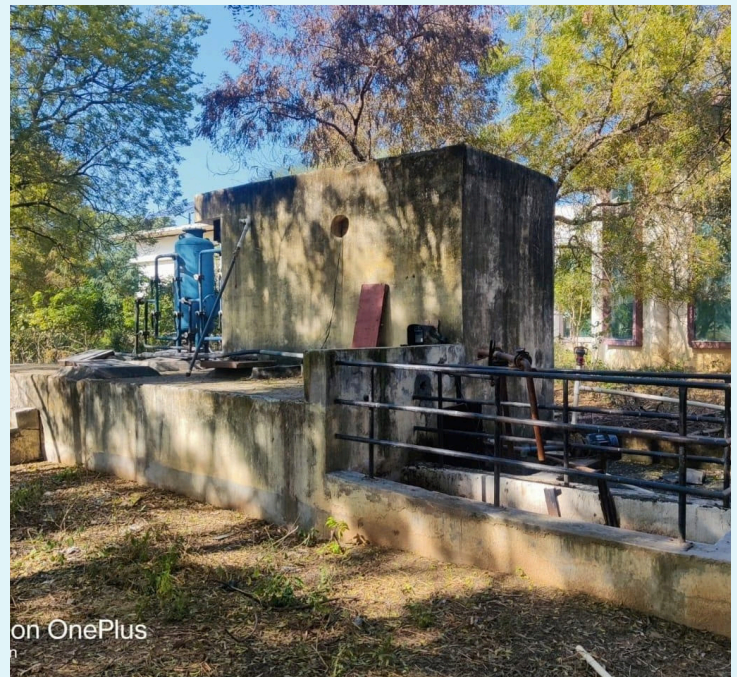
*Figure: Defunct Sewage Treatment Plant*

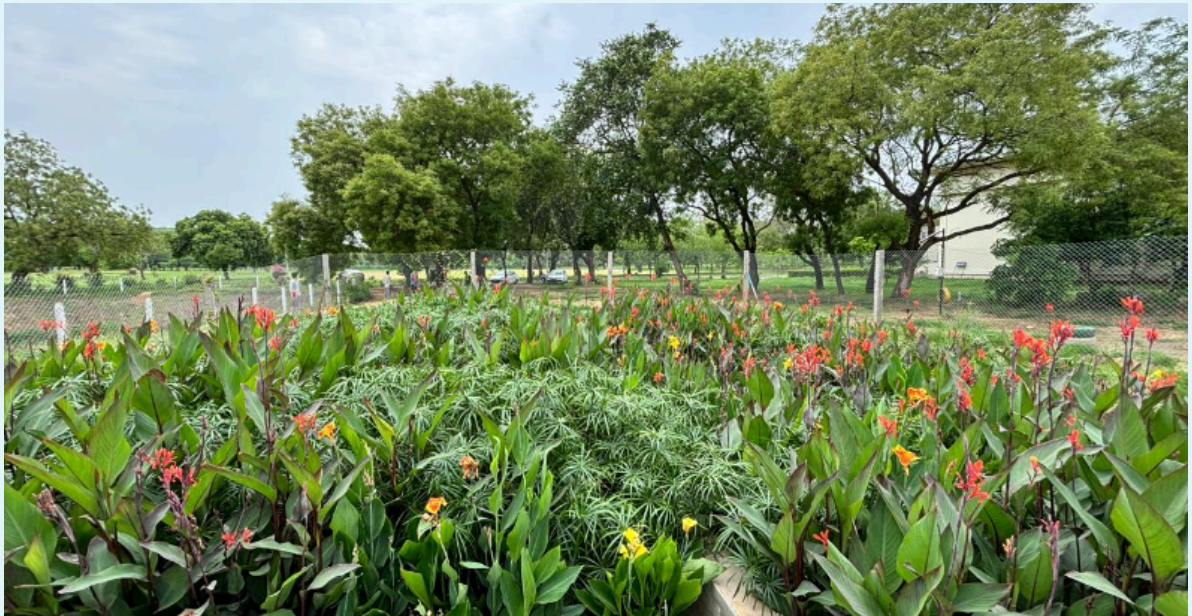
*Figure: Anaerobic Baffled Reactor with vegetated gravel wetlands*

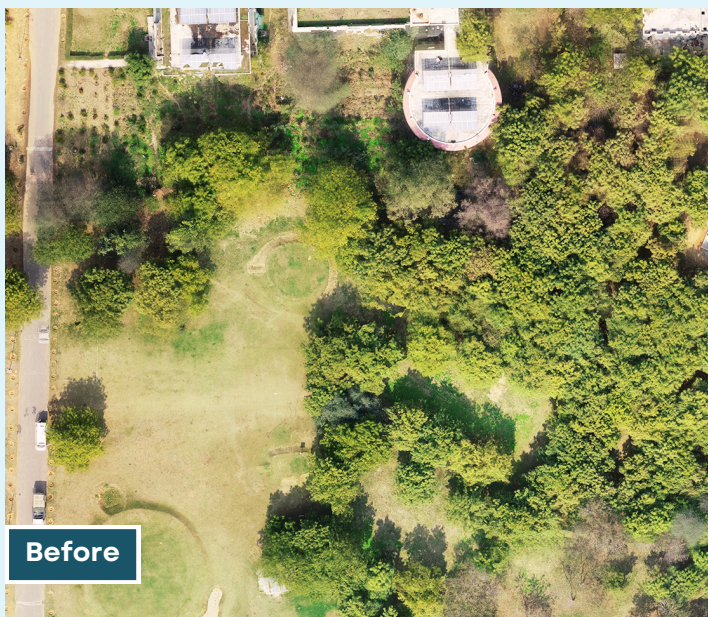
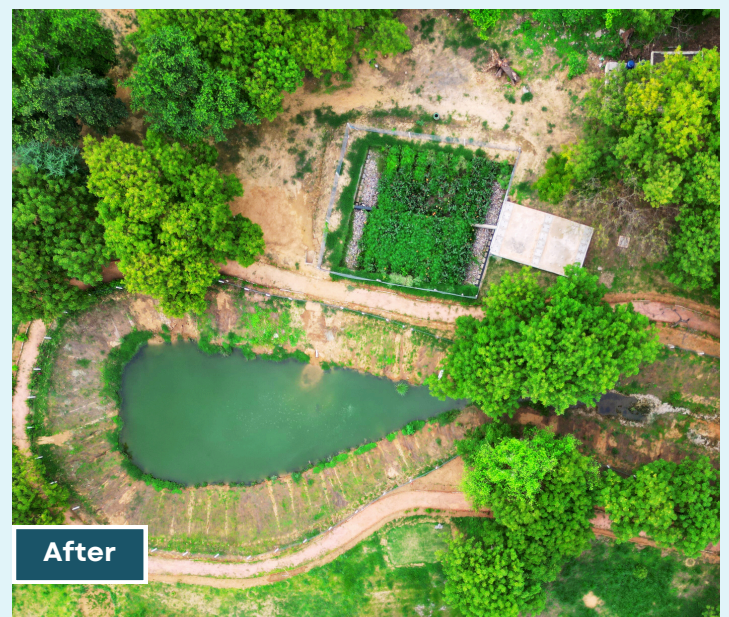
## Ecological Recovery and Monitoring :

The intervention transformed a 0.5-acre degraded sewage site into a vibrant eco-park, with 41 trees, 190 shrubs, 220 sq.m of hedges, and lotus plantations supporting aquatic life and algae control. The site is **estimated to offset 3,500 kg CO<sub>2</sub> over 10 years**. For accountability, 1 Automatic Digital Water Level Recorder tracks groundwater recovery toward the **9.1 million litres/year recharge target**, supported by 3–6 monthly water quality audits. Long-term maintenance is strengthened through capacity-building sessions for BSF Jawans.

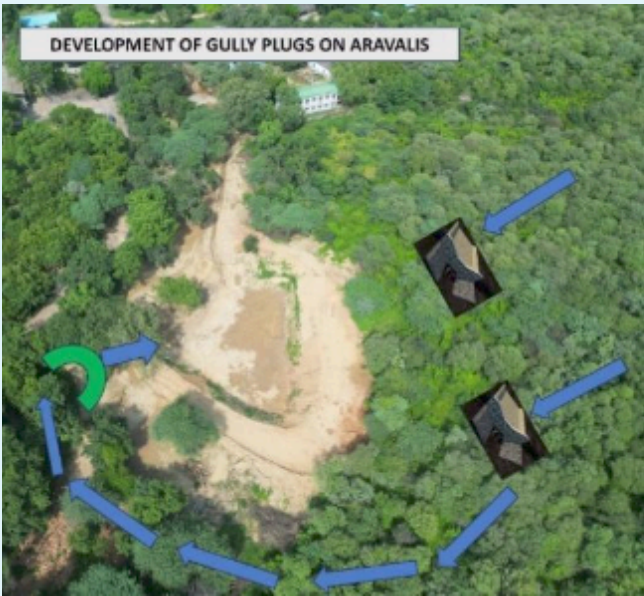
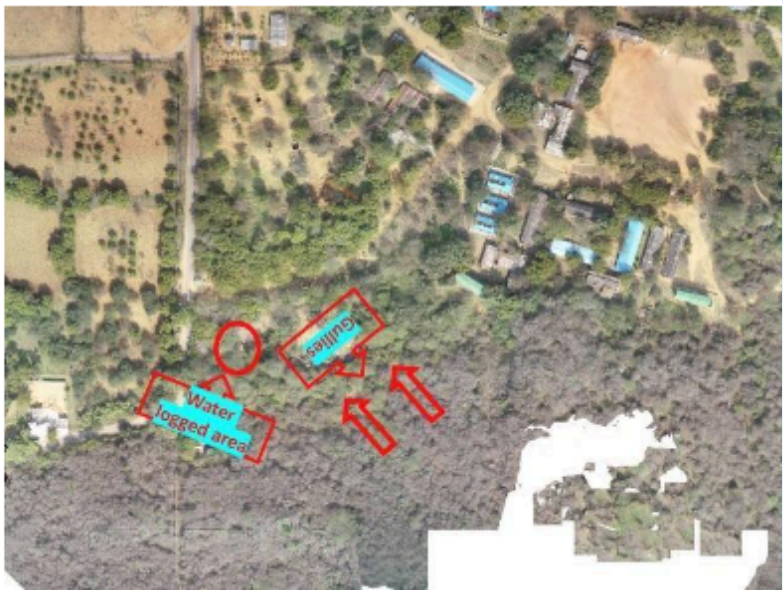
- Runoff & Soil Erosion: High-velocity monsoon runoff from the Aravallis caused severe gully erosion, topsoil loss, and structural damage.
- Waterlogging & Poor Infiltration: Poor drainage and low soil permeability led to waterlogging and limited natural recharge during heavy rains.
- Aquifer Depletion: High groundwater dependence highlighted the need to divert surface runoff for deep aquifer recharge.

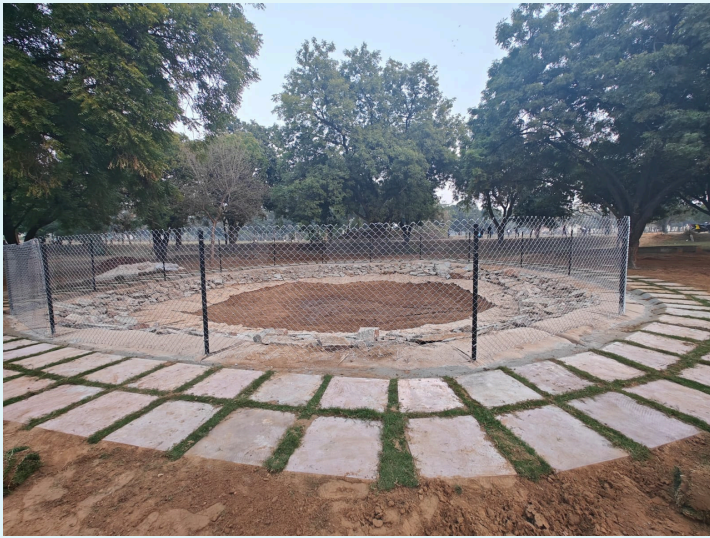
*Figure: Detention Pond*

| Intervention | Design / Configuration | Area / Catchment | Capacity | Key Function / Outcome |
|---|---|---|---|---|
| <div>02</div> <div>DETENTION PONDS</div> <div></div> | Two interconnected detention ponds were developed with vegetated swales, gentle slopes, and stone pitching. | <div></div> <div>13,000 sq. m</div> <div>Catchment area</div> | <div></div> <div>265 kL per pond 530 kL total</div> <div>Capacity</div> | <ul style="list-style-type: none"><li>• Retains stormwater temporarily</li><li>• Enables filtration and controlled percolation</li><li>• Reduces peak runoff</li><li>• Supports groundwater recharge</li></ul> |

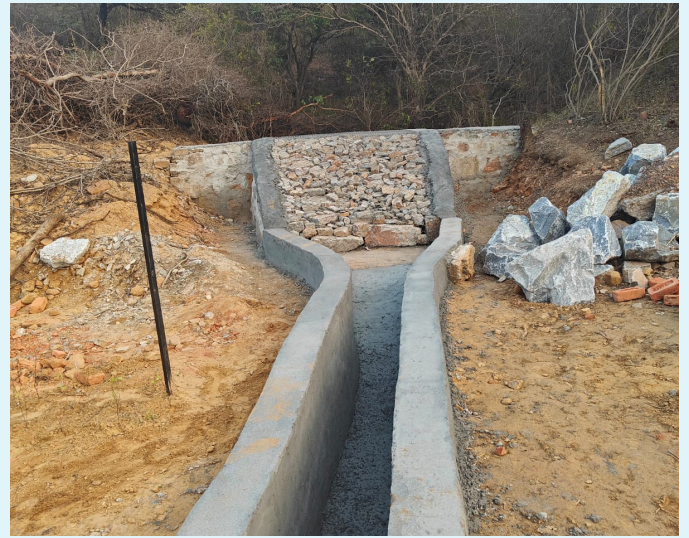
*Figure: Gully Plug for Soil & Water Conservation*

The plugs break the speed of the water coming down the hill. Instead of racing across the campus, the water slows, spreads out, and has time to soak into the ground. Soil that used to wash away now settles behind the stones. Downstream roads and buildings are protected, and the low ground no longer stays flooded after heavy rain.

| Intervention | Design / Configuration | Area / Catchment | Capacity | Key Function / Outcome |
|---|---|---|---|---|
| <div>01</div> <div>GULLY PLUGS</div> <div></div> | Two gully plugs were constructed across natural gullies using stone, brick, cement pitching, and Hume pipes. | <div></div> <div>16,532 sq. m</div> <div>Watershed area</div> | <div></div> <div>390 kL</div> <div>Holding capacity (total)</div> | <ul style="list-style-type: none"><li>• Slows down runoff</li><li>• Traps sediment</li><li>• Reduces soil erosion</li><li>• Promotes groundwater recharge</li></ul> |

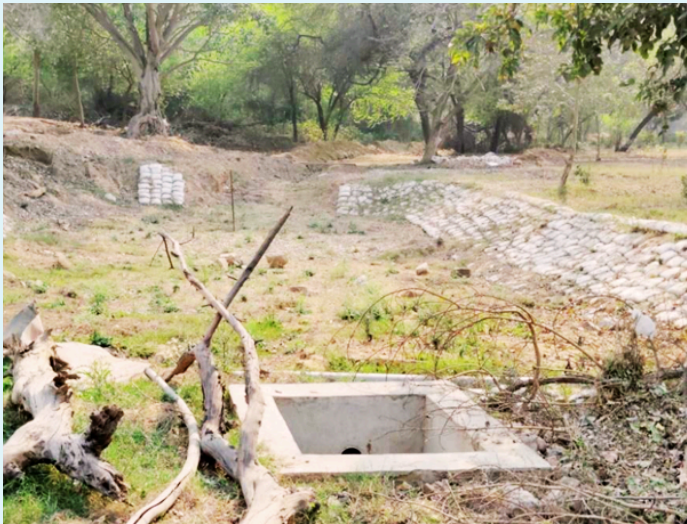
Figure: Dry and Degraded Ponds

- **Pond Rejuvenation & Civil Infrastructure**
  - Pond: Developed a 0.65-acre (904 sq.m) pond with 2.2 m depth and 5.79 million litre capacity.
  - Erosion Control: Geo-Coir matting installed along embankments to stabilize slopes naturally.

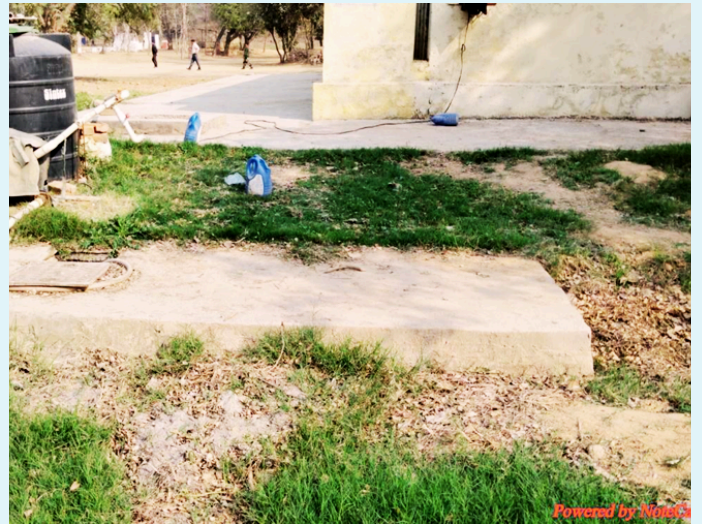
Figure: Septic tanks were leaking and overflowing

- **50 KLD Nature-Based Wastewater Treatment Plant**
  - Pre-Treatment: Collection sump with screening and refurbished settler tanks.
  - Anaerobic Treatment: Underground biodigester/ABR for natural sludge digestion.

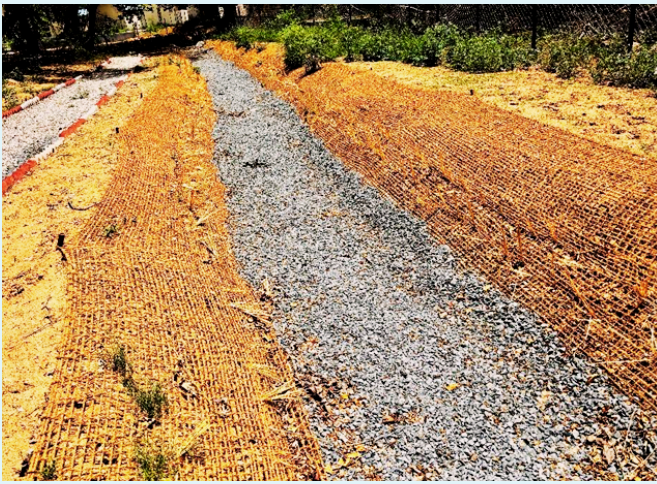
*Figure: Bioswale*

- Constructed Wetland: Gravel-based root-zone wetland for natural filtration.
  - Multi-Stage Treatment: Effluent passes through polishing and spillover ponds and bioswales before entering the main pond.

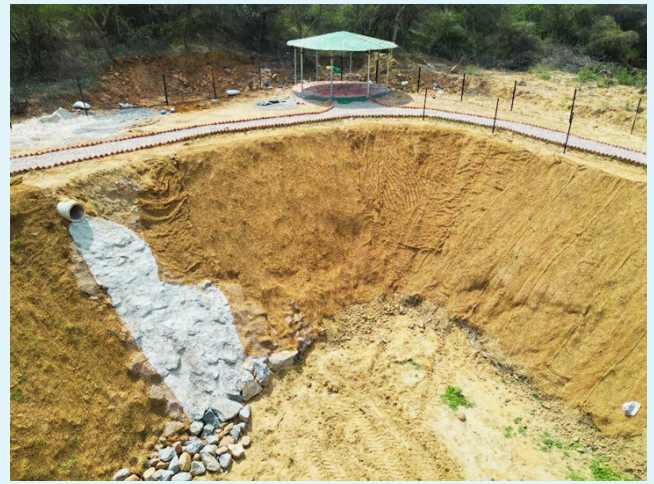
*Figure: Storm water discharge*
